**UNDERGROUND STORAGE TANK
INITIAL SITE CHARACTERIZATION
CUMBERLAND ISLAND NATIONAL SEASHORE**

ST. MARYS, GEORGIA

Technical Report NPS/NRWRD/NRTR-90/01

October 1990

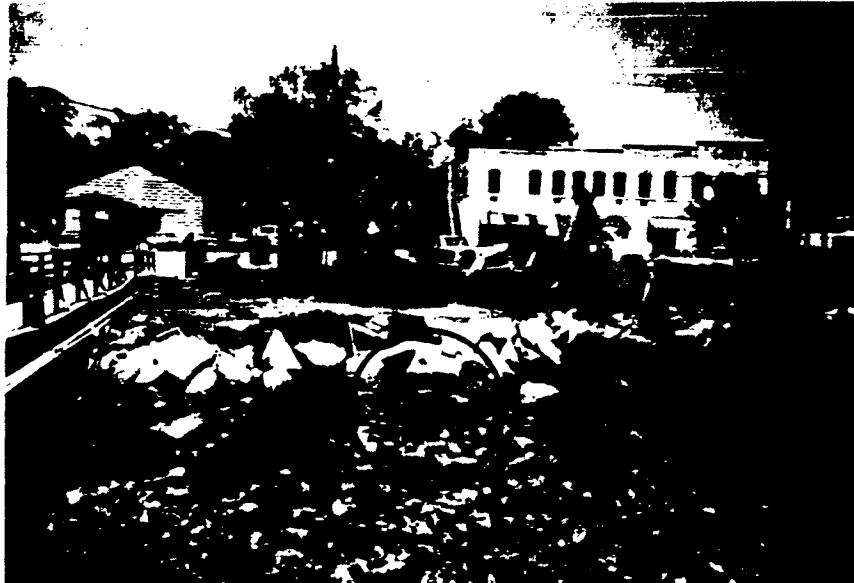
Photo 2. Fuel emergence point (encircled) on the St. Marys River.
Contaminated soil removal is ongoing in background.
May 3, 1989
